DEPARTMENT OF DEFENCE
DEFENCE SCIENCE AND TECHNOLOGY ORGANISATION
AERONAUTICAL RESEARCH LABORATORIES

STRUCTURES REPORT 365

CONSTANT-AMPLITUDE AND PROGRAM-LOAD
FATIGUE TESTS AT LOW CYCLIC FREQUENCIES
ON THICK ALUMINIUM ALLOY PIN JOINTS

SEPTEMBER 1977

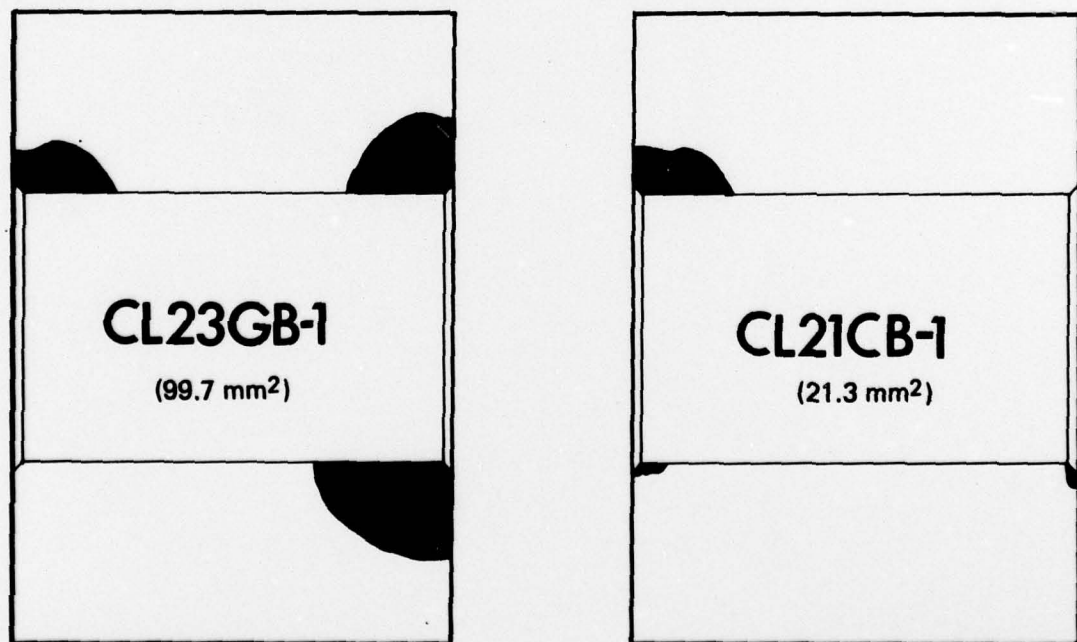
FIG. 7(a) FATIGUE – CRACK AREAS – RESIDUAL STRENGTH TESTS
Constant – amplitude fatigue tests $S_a = 96.5$ MPa, $S_{max} = 216.5$ MPa

were then carefully traced from 4X enlargements—referring to the original fracture surfaces as required, and these are reproduced in Figure 7. Details relating to the failing loads, areas of fatigue cracking and residual stresses for each specimen are given in Table 2. Three of the four ends without fatigue cracks (and also CL24HB-2 which contained a very small fatigue crack) failed in a way typified by Figure 8. All the other specimens failed essentially across the plane of minimum section through the hole.

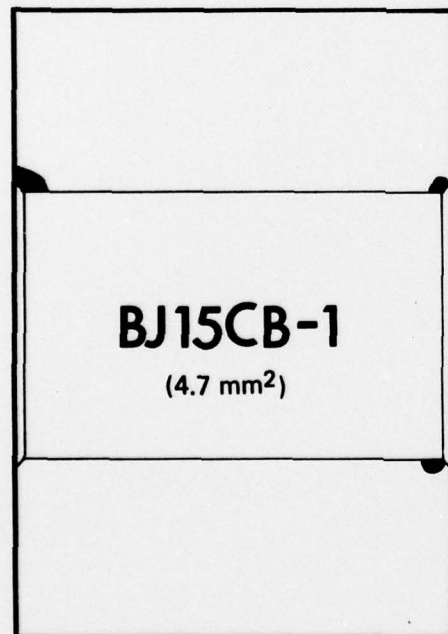
FIG. 7(b) FATIGUE—CRACK AREAS — RESIDUAL STRENGTH TESTS
Constant — amplitude fatigue tests $S_a = 70.7$ MPa, $S_{max} = 164.8$ MPa
